#### The International Journal of The Nautical Institute

## Mariners' Alerting and Reporting Scheme

#### MARS Report No. 269 March 2015

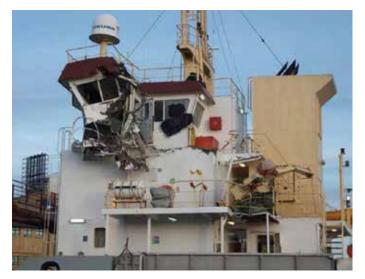
The coast guard TSS services, seeing the movements on radar, became aware that an ambiguous situation was developing and called the OOW of the general cargo vessel. A short conversation ensued and the TSS services inquired if the general cargo vessel was executing a 360° turn. Although this was not the OOW's plan, he replied in the affirmative to TSS services; immediately after this conversation, the OOW selected hand steering and applied 35° starboard helm. Since the vessel was equipped with a high lift rudder the rate of turn increased rapidly. He did not realise that the bulk carrier was now about 500m off his starboard beam.

Meanwhile, the bulk carrier's OOW had also been contacted by the TSS services and after a short conversation this OOW ordered hard port helm. Although he had been monitoring and was now aware that the general cargo was to do a 360° turn, he did not think this manoeuvre was already underway. He assumed that the general cargo would pass ahead before starting the 360° turn. But within seconds he noticed that the cargo vessel was turning quickly towards him so he immediately ordered hard starboard helm. Nonetheless, soon afterwards the two vessels collided.
